The Fishlake and Fishlake Meadows: A Managed Medieval Landscape

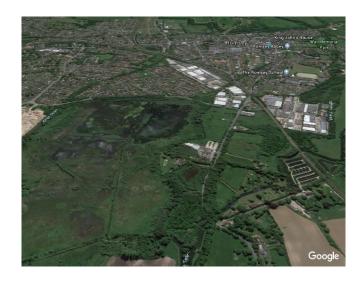
The overhead view gives a good indication of how Romsey fits into its surroundings. The built-up areas of housing and industrial estates are spilling across the fields to the east of the Test. This urban spread contrasts sharply with the rural, agrarian landscape to the west. Fields bordering the river are a lush green. Looking south across Fishlake Meadows, the Fishlake stream and Greatbridge Road provide a link between the river valley and the town.

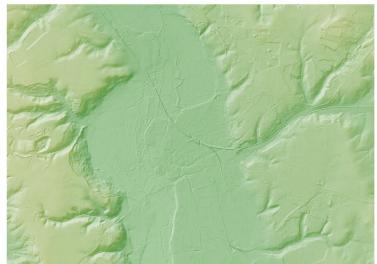
A LiDAR image shows a 3D view of the surface of the land. The image is produced by processing the data, the heights of individual points on the ground, to indicate slopes by the use of shadows or highlights. This view shows the valley of the Test bounded by higher ground to the east and west. The steeply sloping land edging the valley on the west is depicted in deep shadow. The west facing scarp on the other side of the valley is lit up by the virtual light source. This perception of depth shows the dendritic patterns cut into the land by water erosion. The Tadburn stream has cut a valley through the plateau as it flows west towards the Test along the southern edge of Romsey. The railway, running for much of its length on an embankment, crosses the valley and continues east alongside the Tadburn. The topographic feature of prime importance to Romsey is barely visible on the LiDAR, its edge marked by a highlight.

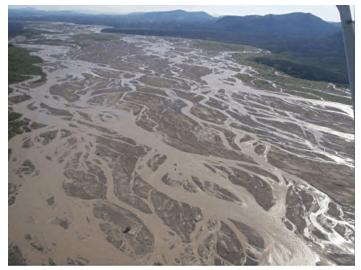
During the Ice Age seasonal melt water 5 would have carried large quantities of earth and frost-fractured rock into the river valleys. The sediment would have choked the valleys and produced highly braided rivers. These braids would shift position as individual channels were blocked and then infilled with sediment. The ancient, silt-filled channels that are preserved in floodplain deposits are known as paleochannels.

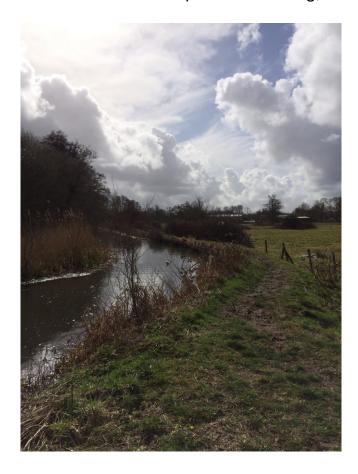
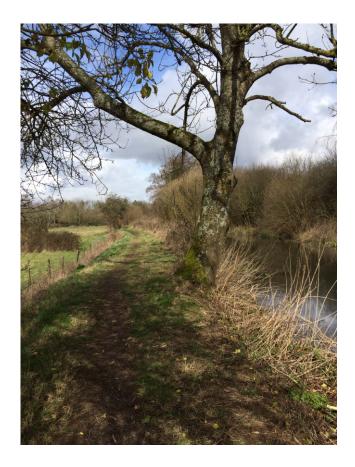
The Greatbridge leat and the Fishlake share basic features in their design. Both consist of a section carrying water across the floodplain to the edge of a river terrace. In the case of the Fishlake the water is contained within two artificial banks. The Greatbridge leat uses the terrace as one side of the waterway. In both systems the water continues through a cut channel before eventually returning to the Test. The Fishlake is on a larger scale and is more complex with its long, embanked water carrier. When was it built?

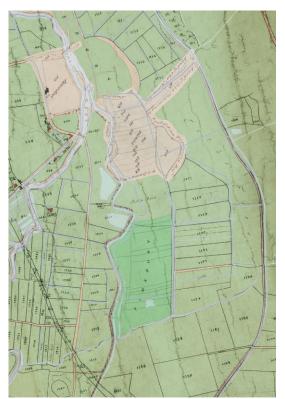
This map shows a composite of the mid 19th century tithe maps of Romsey, Michelmersh and Timsbury with the modern surface water in blue. The land belonging to each parish was divided into small fields, a clear indication of the value of the meadow land. The Michelmersh section included a broad drove road. This still exists, now forming the main entrance into and across the meadows.

The composite tithe map shows a number of interesting features in the landscape. I have already mentioned the causeway that runs alongside the Fishlake. The word causeway comes from the Norman French word causie, meaning a bank, plus 'way', a path or routeway. Today we still separate the two components - we say that Greatbridge Road runs along Greatbridge causeway. The road is referred to in the Romsey Anglo-Saxon charter as the street. The Old English equivalent of causie was 'bridge'. The banks of the Fishlake would have been built of chalk or clay. The bridge, what we now call the causeway, did not have to retain water so it would have been built of gravel. The gravel could have been guarried from the nearby river terrace. The Old English word for gravel is 'greot'. The causeway was likely to have been referred to as greot bridge. It extended up to the Test which would have been crossed by either a ford or a bridge - in the modern sense of the word. Now, of course, the road crosses the river via Greatbridge. Is it really such a great bridge?
