The northern boundary of the Nursling charter runs from the Test, across the floodplain and onto the river terrace on the east side of the valley:

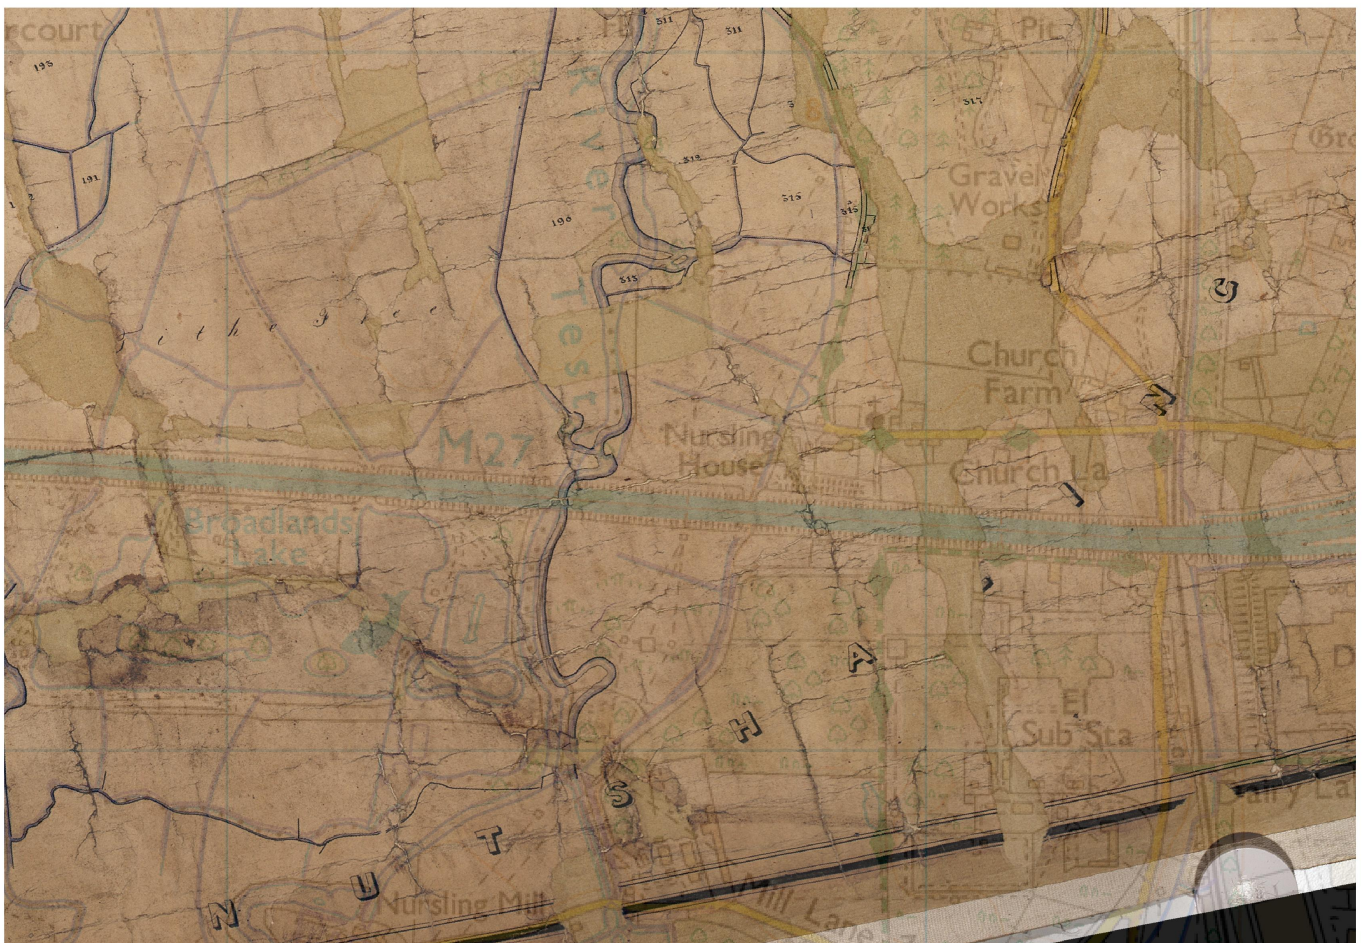
The image above shows the Romsey tithe map overlying a modern OS map. The current boundary between Romsey and Nursling is indicated by a dotted line. The Test has lost a couple of tight bends since the tithe map was drawn in 1845.

Charter boundary clauses give a point to point description of features, proceeding in a clockwise direction. On a boundary shared by neighbouring estates, the surveys travel in opposition directions. There appears to have been a significant change in the topography of the floodplain along the Nursling/Romsey boundary in the century between the two charters. The north boundary of Nursling in 877 runs east from the Test along the boundary stream across the width of the floodplain. In Romsey's charter of c972, the stream has been replaced, from east to west, by the *heat/hae* (probably *heaf* meaning sea or water), a dead lake (stagnant water) and an island. The westernmost point is the Old Test. The Test has apparently been moved to a new main channel on the east side of the floodplain.
